The fire resistance performance of two single leaf single acting doorsets with glazing, when tested in accordance with BS 476: Part 20/22: 1987

391843

Falcon Panel Products Ltd

11th November 2017

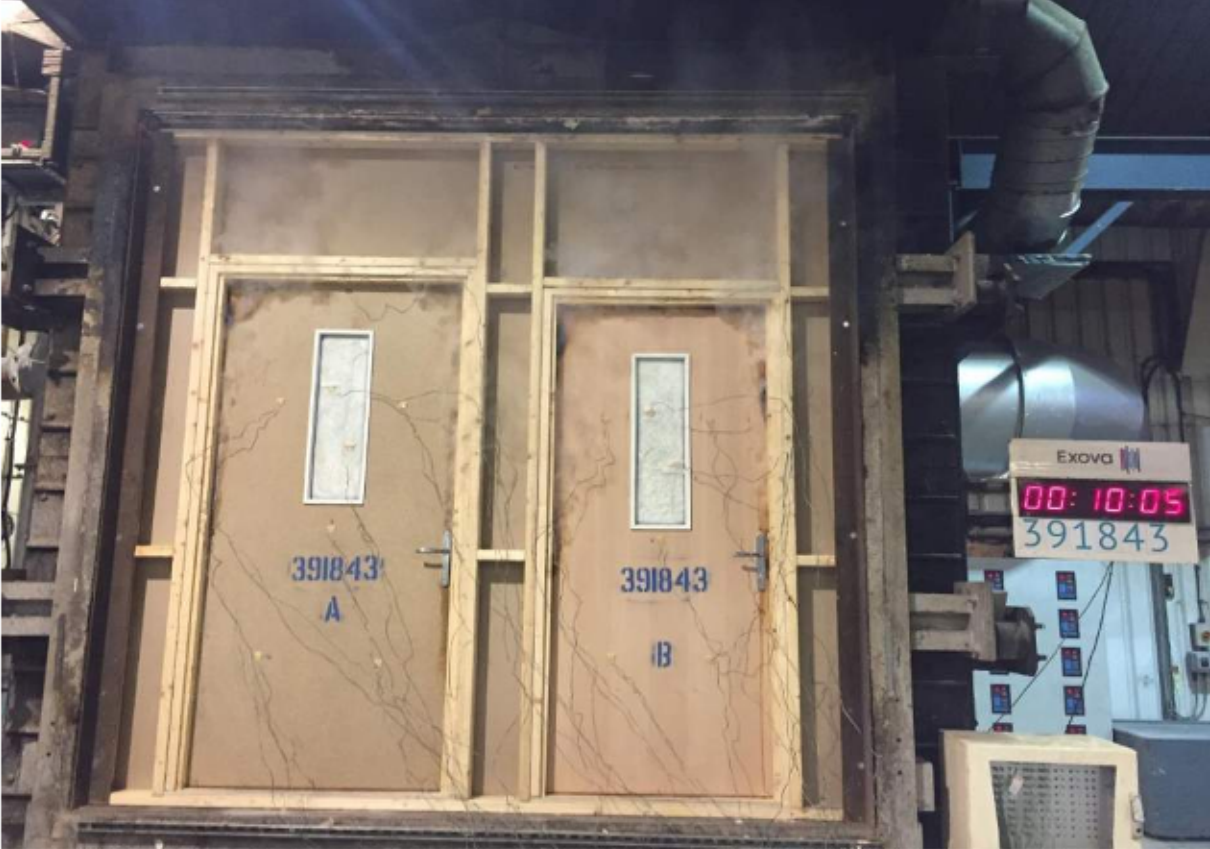
After 10 minutes

08:54	A, there is smoke issuing from the middle hinge position.
09:35	A, there is smoke issuing through the cracks in the glazing.
10:30	A, there is discolouration to the closing edge.

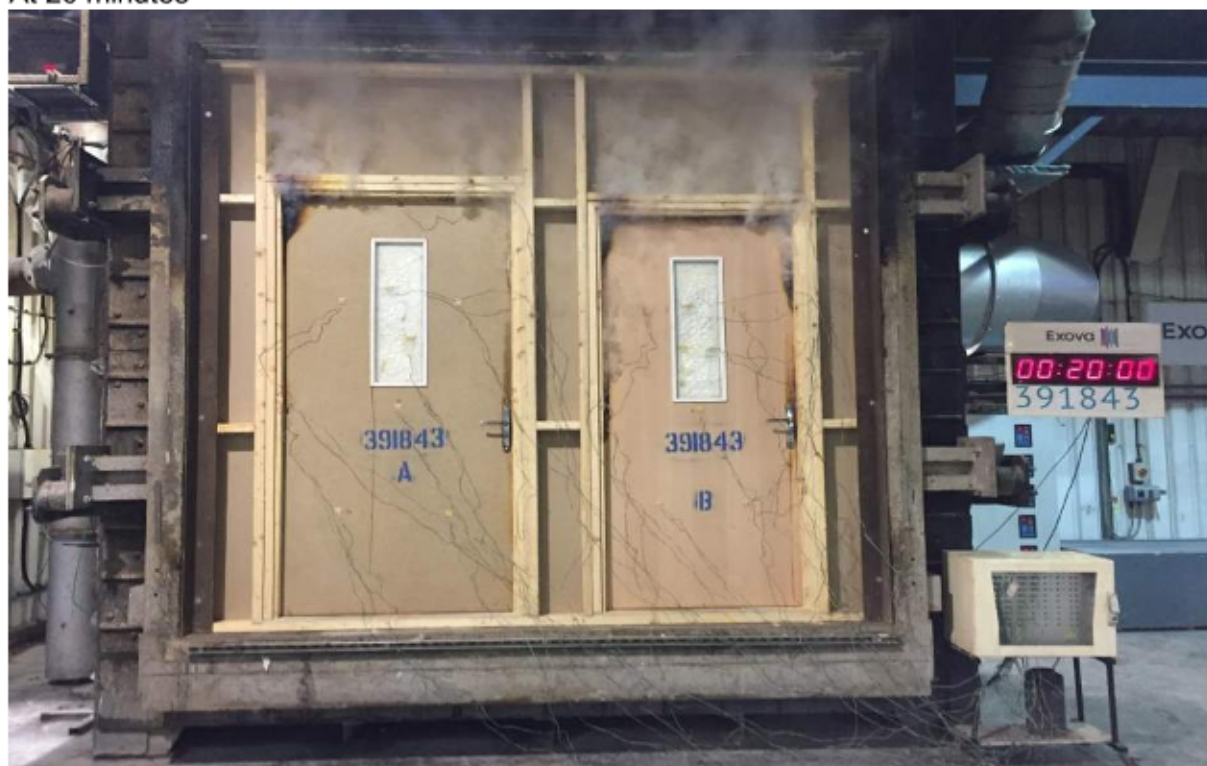
At 20 minutes

17:30	B, there is smoke issuing through the cracks in the glazing.
19:20	A, there is discolouration to the head approximately 200mm from the top closing corner.

20:20 B, there is further discolouration to the top half perimeter.

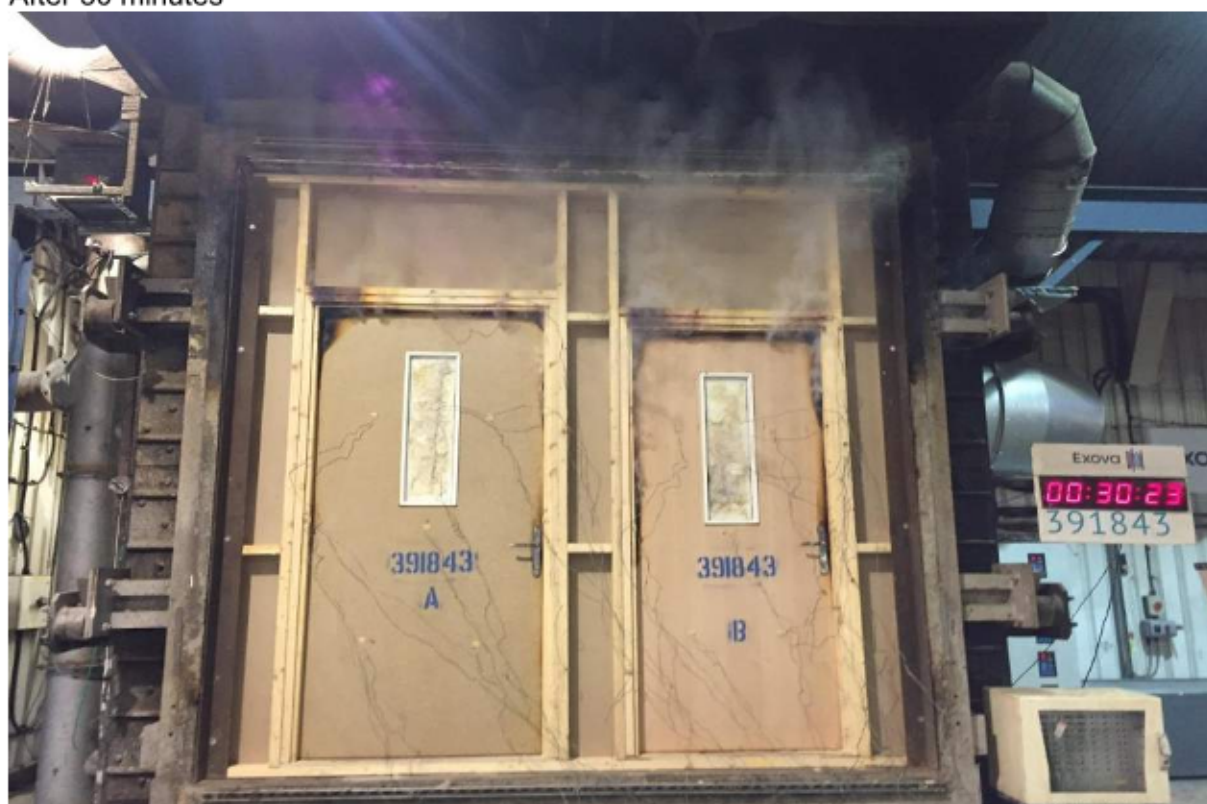
After 30 minutes

29:28 A, a cotton pad integrity test was performed at the top hinge position which did not result in the ignition of the cotton pad. No failure.

30:16 B, a cotton pad integrity test was performed at the top hinge position which did not result in the ignition of the cotton pad. No failure.

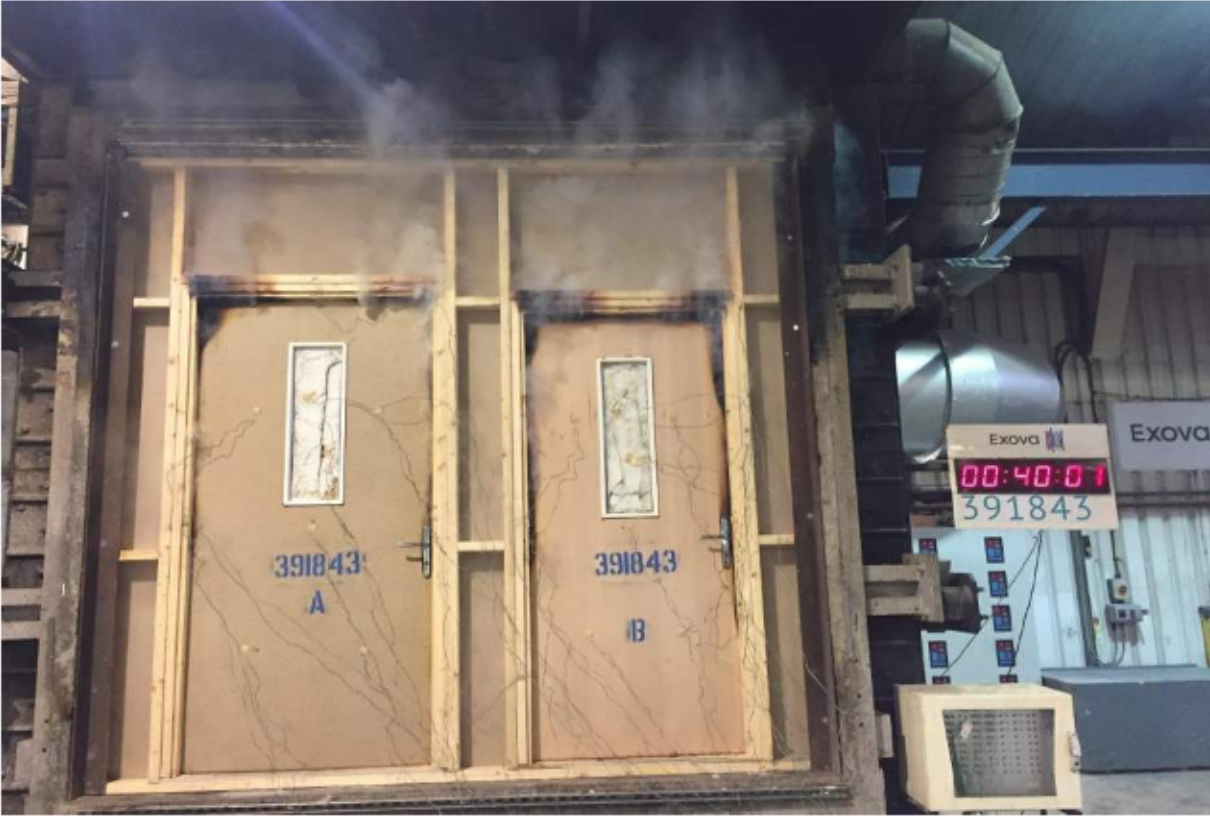
After 40 minutes

41:38 B, a cotton pad integrity test was performed at the middle hinge position which did not result in the ignition of the cotton pad. No failure.

42:42 A, a cotton pad integrity test was performed at the top hinge position which did not result in the ignition of the cotton pad. No failure.

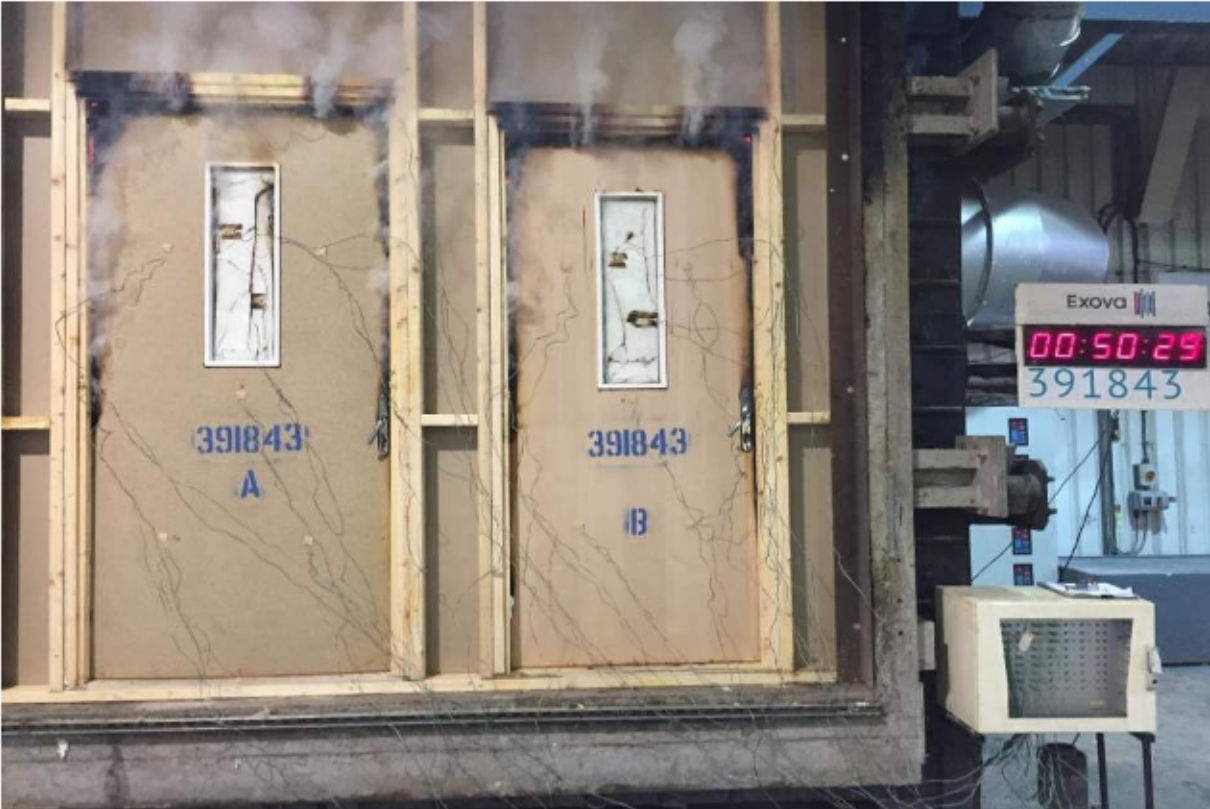
After 50 minutes

- 47:09 B, a cotton pad integrity test was performed at bottom hinge position which did not result in the ignition of the cotton pad. No failure.
- 47:24 B, a cotton pad integrity test was performed at the bottom hinge position which resulted in the ignition of the cotton pad thereby constituting **integrity failure**.

- 48:23 A, a cotton pad integrity test was performed at the top hinge position which did not result in the ignition of the cotton pad. No failure.
- 49:00 B, there is continuous flaming at the bottom hinge position thereby constituting **further integrity failure**.

- 50:00 A, a cotton pad integrity test was performed at the top hanging corner which did not result in the ignition of the cotton pad. No failure.
- 50:20 B, a cotton pad integrity test was performed at the top closing corner which did result in the ignition of the cotton pad thereby constituting **further integrity failure**.

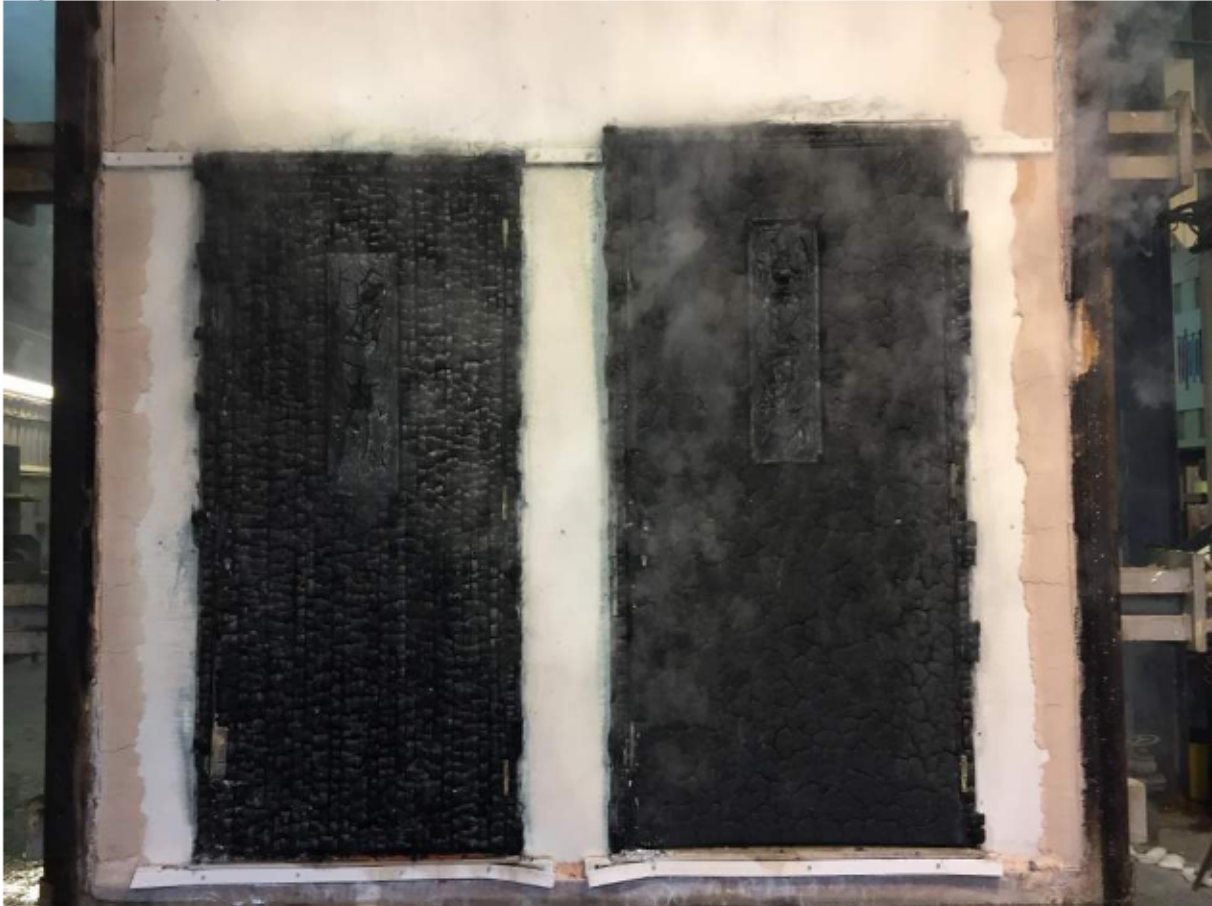
Exposed face – post test

Doorset A	Doorset B
Integrity	51 (fifty one) minutes	47 (forty seven) minutes
Insulation	36 (thirty six) minutes	39 (thirty nine) minutes
