TEST REPORT NUMBER CFR1905311_1

Summary of test specimen:

A single leaf timber doorset, tested opening into the furnace as a latched, unbolted and insulated doorset.

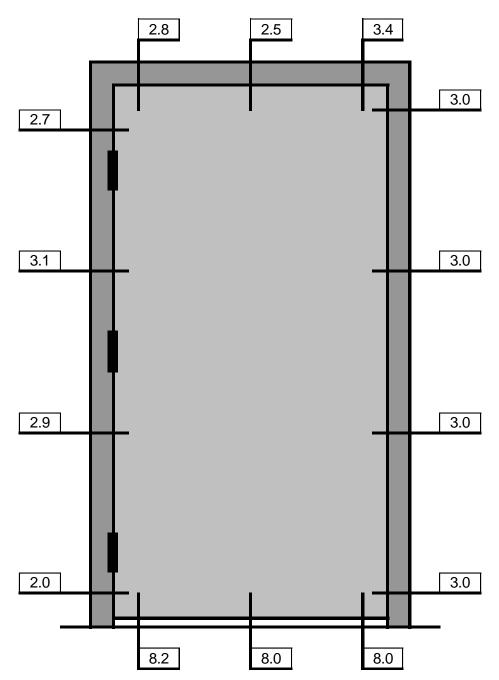
The gap between the leaf edges and the frame and at the threshold was measured on the exposed face prior to the start of the test. The following figure shows the position at which the measurements were made and the recorded gap (mm) at those positions.

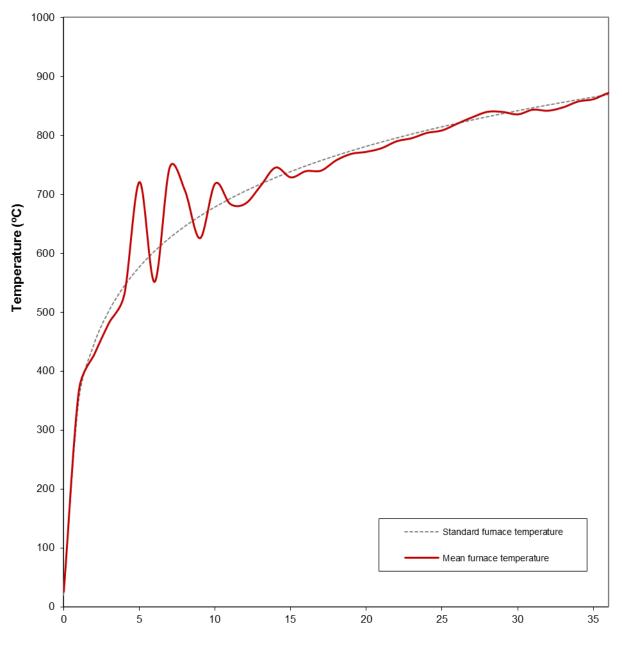
Furnace temperature was controlled so as to follow the standard temperature/time curve defined in the test standard and within the tolerances permitted. The furnace mean temperature was calculated from the output recorded using five furnace thermocouples of the design specified in the test standard. The following graph shows the standard and mean furnace temperature/time data.

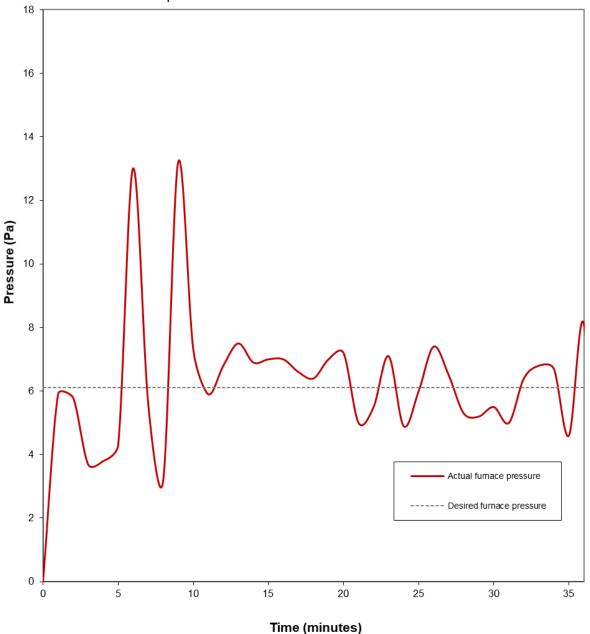
Furnace pressure was maintained for the duration of the test at a nominal + 6.1 Pa measured at the pressure sensing head. When a linear pressure gradient of 8.5 Pa/m is applied this equates to + 0 Pa at 1 m above the notional floor level. The furnace pressure was controlled within the tolerances permitted in the test standard except for 3 instantaneous occasions which were transient events. The following graph shows the actual and desired furnace pressure/time data.

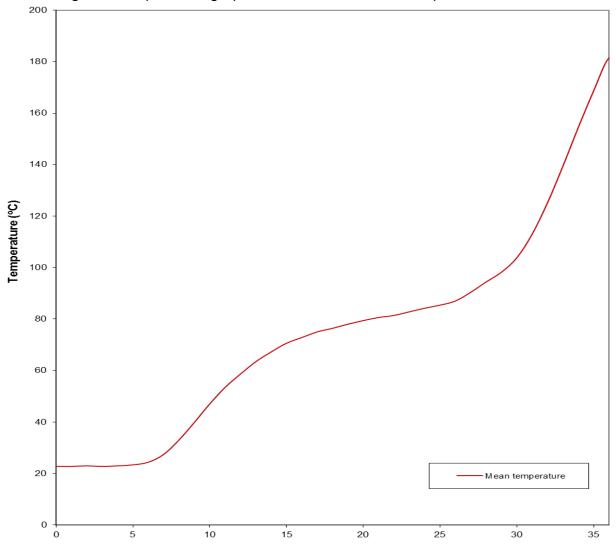
The following time/temperature graph shows the mean leaf temperature.

Doorset leaf	Channels 16 to 20	(mean & maximum)
Doorset frame	Channels 21 to 23	(maximum only)

The recorded data of all individual thermocouples is shown in the tables in Appendix 4.

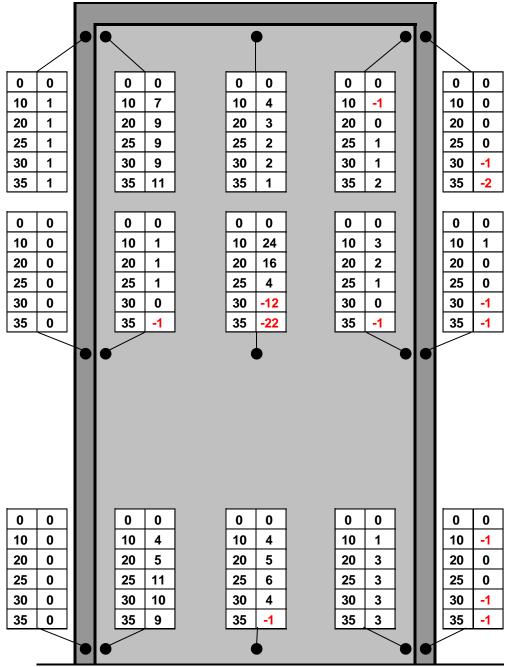
Taut stainless-steel wires were anchored horizontally across the unexposed face of the specimen such that any deflection experienced by the test specimen could be measured. One wire was positioned 10 mm vertically below the head of the leaf, the second at midheight and the third 10 mm vertically above the threshold. The following figure shows these positions with the elapsed time (minutes) in the left-hand column and the recorded deflection (mm) in the right-hand column. Positive values indicate deflection towards the heating conditions of the test.

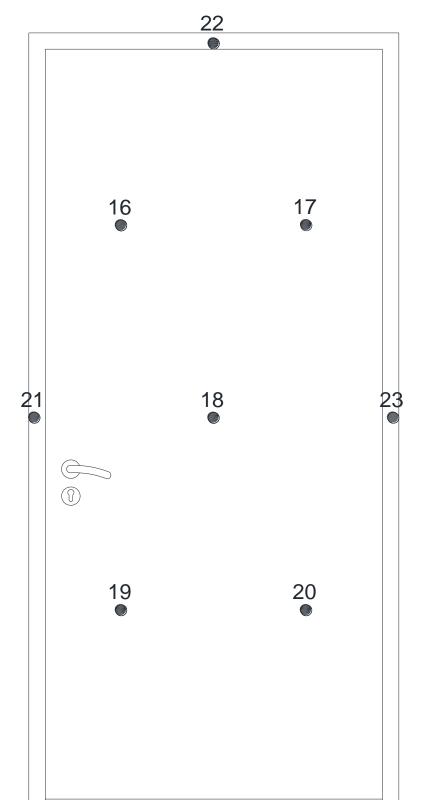
APPENDIX 3 POSITIONING OF INSTRUMENTATION

• Unexposed face specimen thermocouple

The positions of these thermocouples are shown in Appendix 3.
