C A M B R I D G E  
**FIRE RESEARCH**

## TEST REPORT NUMBER CFR2008041\_1

### FIRE RESISTANCE TEST IN ACCORDANCE WITH BS 476: PART 22: 1987

2No. single leaf timber doorsets, the left-hand doorset opening into the furnace and the right-hand doorset opening away from the furnace. Both doorsets tested as latched, insulated doorsets.

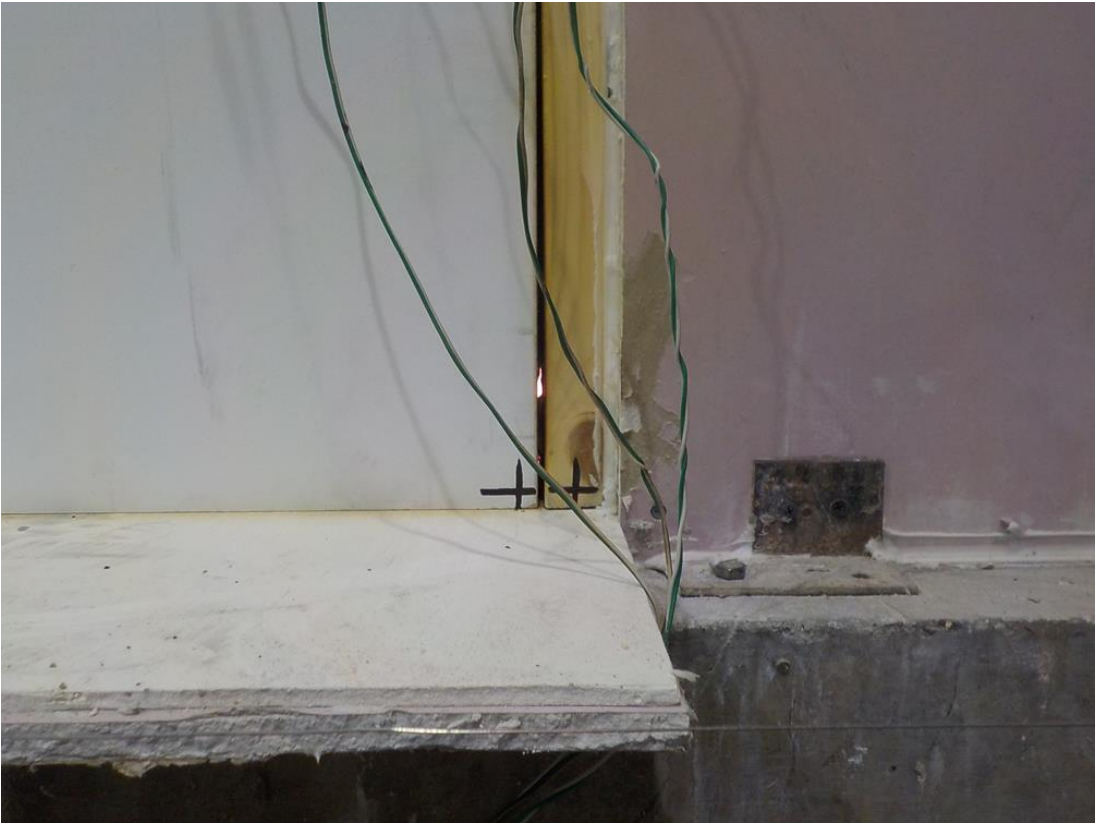
Photo 2.2.7 – Right-hand leaf after 33 minutes

33:02	U	Glow at closing stile nominally 30mm above leaf base.
33:20	U	Flash flaming occurs at closing stile nominally 30mm above leaf base.
33:35	U	A cotton pad is applied at closing stile nominally 50mm up from leaf base.

33:42	U	<b>INTEGRITY FAILURE</b> due to ignition of cotton pad. <b>INSULATION FAILURE</b> due to integrity failure.
36:35	U	Flash flaming occurs at nominally 200mm below strike position.
